United Nations Mission to Investigate Allegations of the Use of Chemical Weapons in the Syrian Arab Republic

Report on the Alleged Use of Chemical Weapons in the Ghouta Area of Damascus on 21 August 2013

Report on Allegations of the Use of Chemical Weapons in the Ghouta Area of Damascus on 21 August 2013

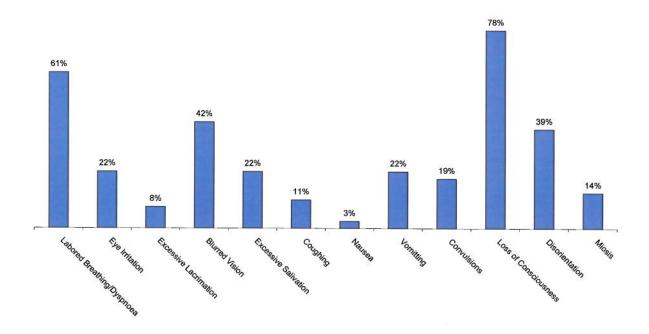
Chart: Symptoms and signs of survivors (N=36)

The main symptoms reported by survivors included loss of consciousness (78%), shortness of breath (61%), blurred vision (42%), eye irritation/inflammation (22%), excessive salivation (22%), vomiting (22%), and convulsions/seizures (19%). The full range of symptoms and signs are presented in the chart below.

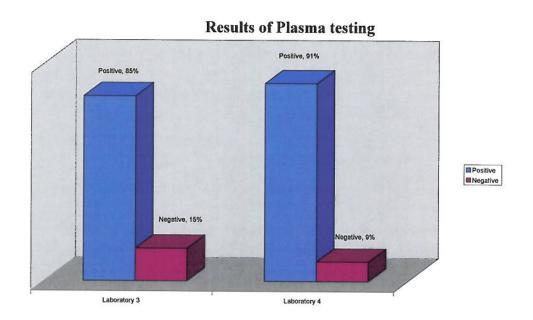
Table 2: Results of biomedical testing

Conclusion. The positive blood and urine specimens provide definitive evidence of exposure to Sarin by a large proportion of the survivors assessed by the investigation Mission. These results are corroborated by the clinical assessments, which documented symptoms and signs that are consistent with nerve agent exposure, including shortness of breath, eye irritation, excessive salivation, convulsions, confusion/disorientation, and miosis. The findings of the clinical assessments were consistent with information derived from both the interviews with clinicians and the review of medical records, which each reported symptoms and signs consistent with nerve agent exposure.

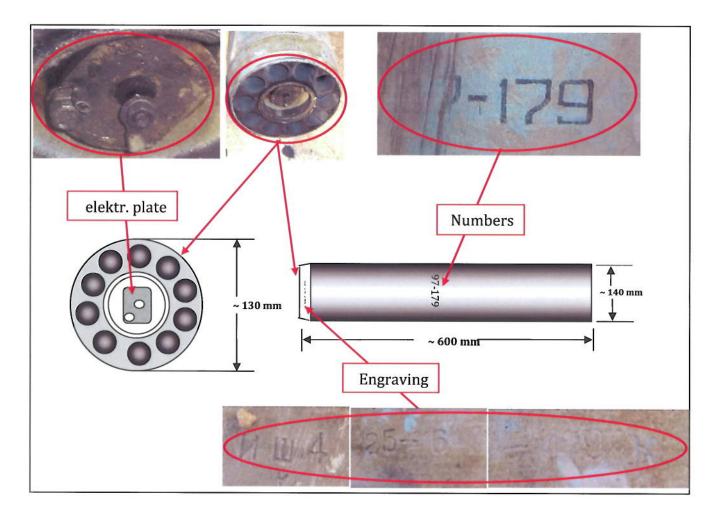
Markings:

1. Black numbers on the outside: 97-179

2. Engravings on the bottom ring of the engine: Γ И III 4 25 - 67 - 179 K Dimensions:

Length $\sim 630 \text{ mm}$ Width $\sim 140 \text{ mm}$

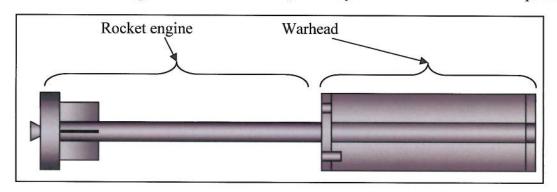
Below is a drawing of the found ordnance, the body has been divided into two parts.

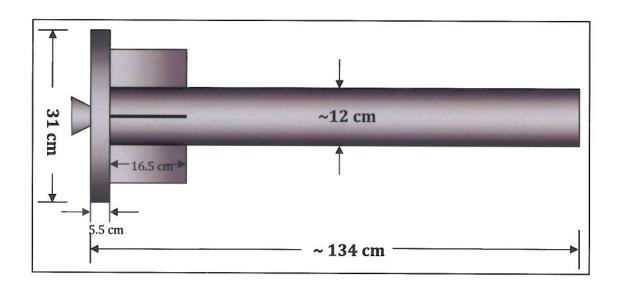
The rocket engine:
Six stabilizer fins are equally arranged in a circle and stabilized with a metal ring. One rocket had a red number 153 sprayed in the middle of the engine tube. The engine tube is attached to the warhead with 12 bolts.

- Total length of the engine: ~134 cm (exit nozzle not included)
- Length of rocket motor fins: ~16.5 cm
- Width of stabilizing ring: ~5.5 cm
- Length of motor exit nozzle: ~4.5 cm
- Length of motor engine shaft: ~112 cm
- Ø of engine shaft: ~12 cm
- Ø of stabilizer ring: ~31 cm

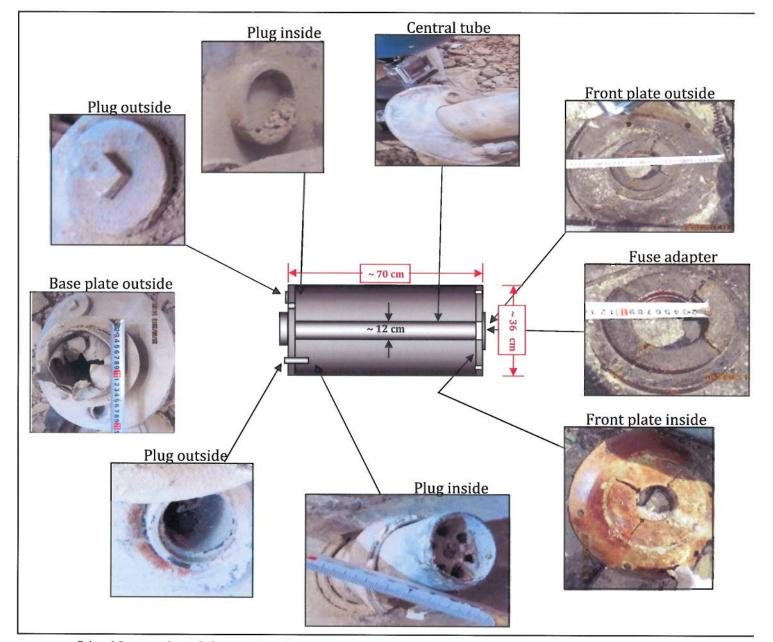
The warhead consists of:

- Front metal plate with a fuse thread in the center
 - Ø outside: ~ 36 cm
 - Ø fuse thread: ~ 9 cm

- Six threaded attachment holes are equally arranged in a circle near the outer ring
- Body / outer container consisting of metal plate
 - Thickness ~ 5 mm
- Metal base plate with filling plug, tube and attachment ring with 12 bolts.
 - Ø outside: ~ 36 cm
 - Ø square bolt ~ 7 cm
 - Ø integrated tube on the base plate ~ 3 cm
 - Length of the tube ~ 10 cm
- Central tube of the warhead
 - Length of tube: ~ 70 cm
 - Ø of the tube: ~ 12 cm

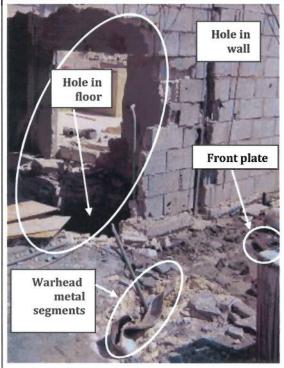
Liquid capacity of the warhead:

The approx. capacity of liquid in the warhead is according to the measurements between 56 ± 6 liters. This calculation is exclusive to the thickness of the container walls and any other unknown components possibly contained in the warhead.
